# RADIUM-226 SOURCE REMEDIATION

Lowerline and Coolidge Streets  
New Orleans, LA

A presentation for the City of New Orleans

January 18, 2019

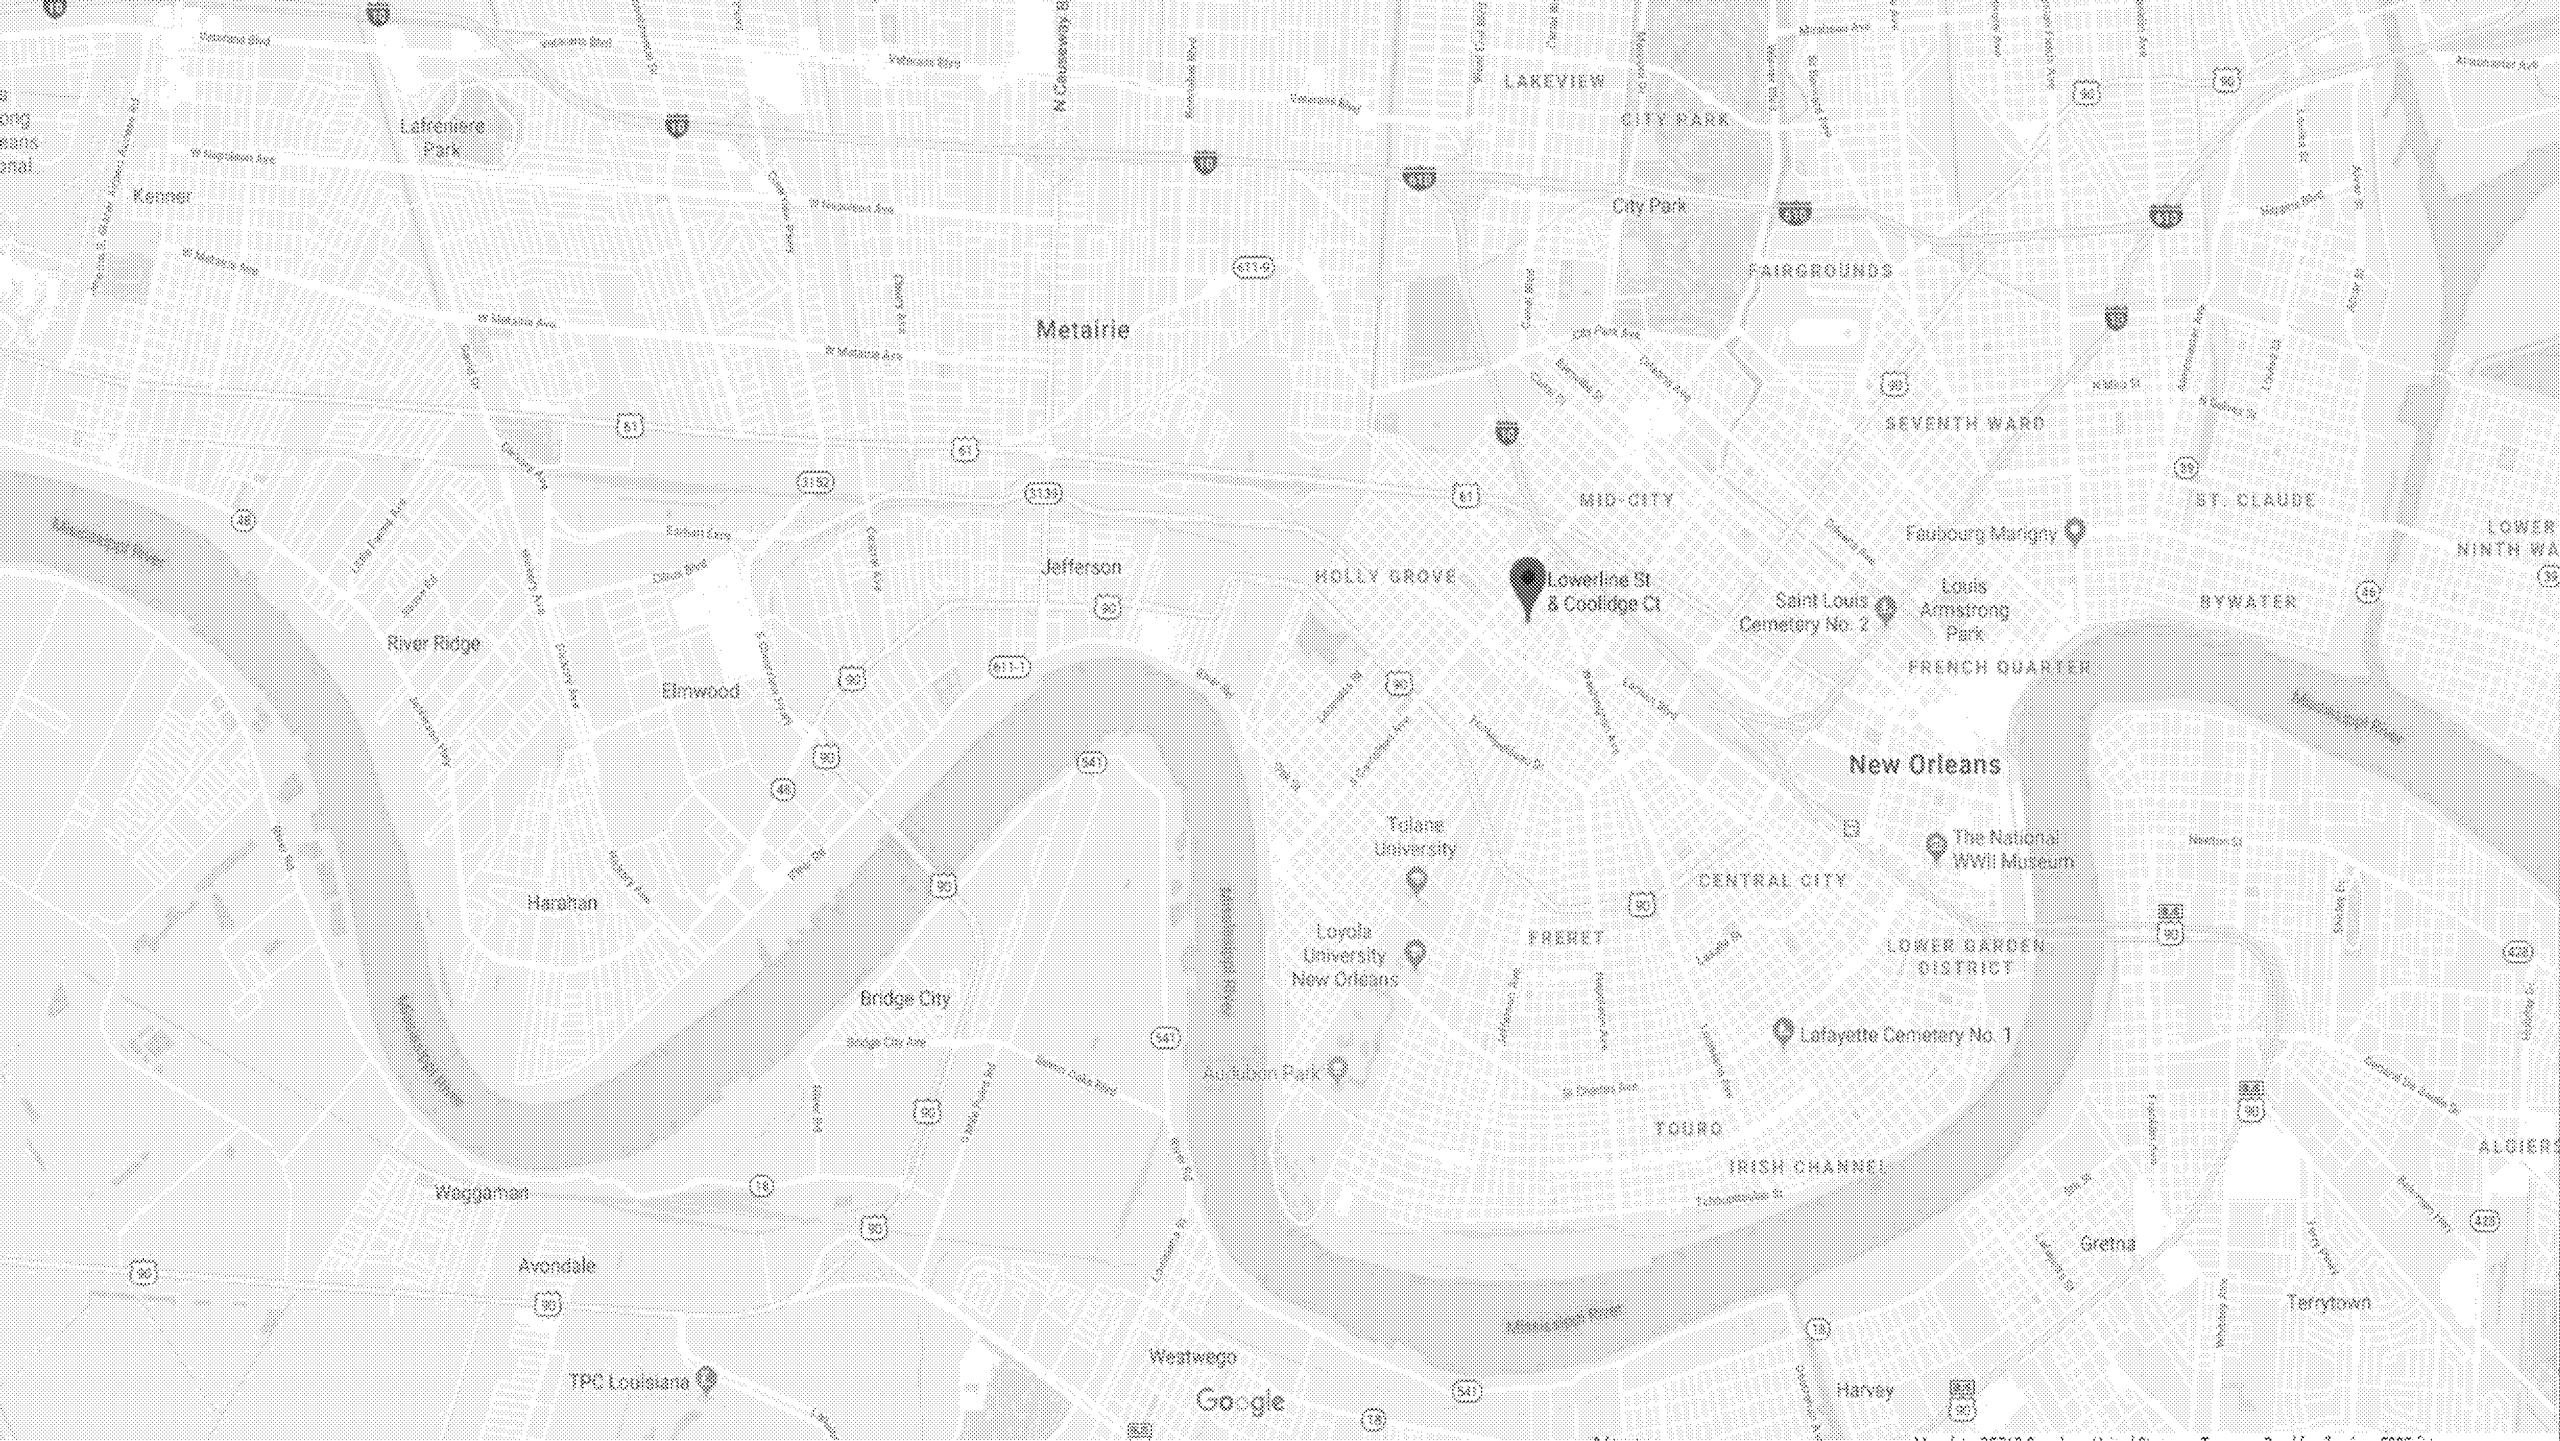
## HISTORY AND SITE DESCRIPTION

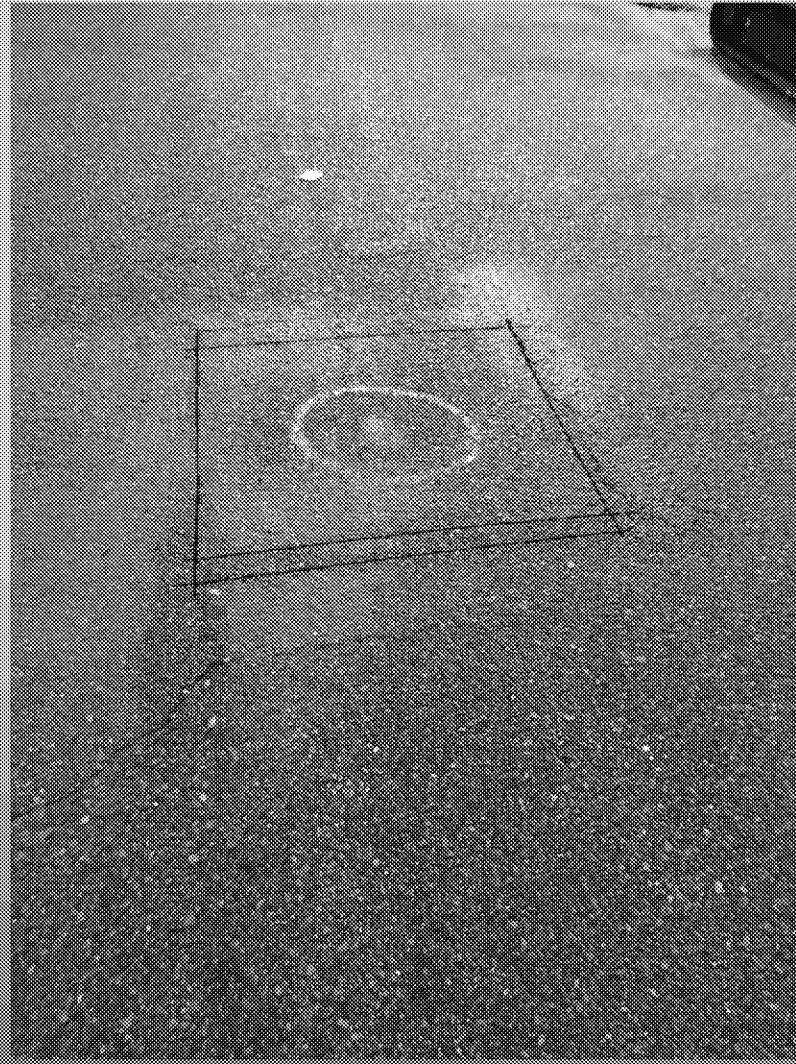
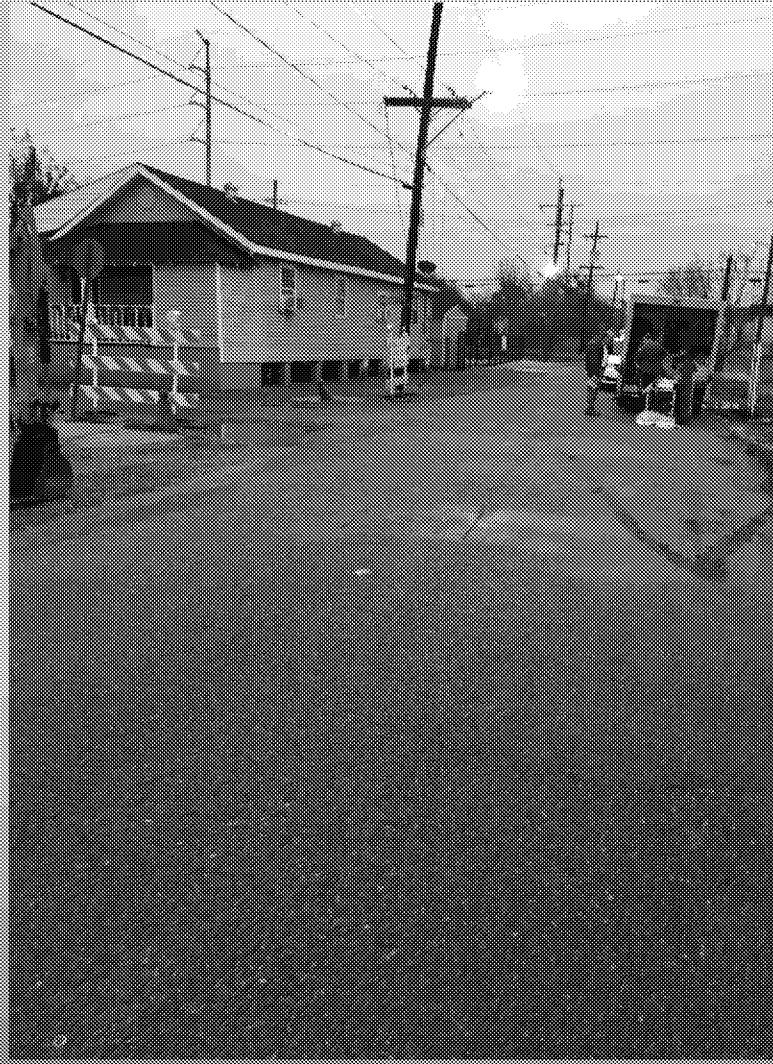
## DESCRIPTION OF PHASE 1 ACTIVITIES

- Concrete saw used to cut asphalt approximately 3'x3' around the location.
- Air sampling in and around the work area conducted.
- Mini-Excavator used to removed asphalt and set aside. Surveyed and released as clean.
- Subsurface material removed in lifts, surveyed, and placed into prepared drums.
- Excavation to a depth of approximately 24—30 inches.
- Material screened visually and with dose rate meter for “source”.
- Magnitude and extend found exceeded scope – excavation halted.
- Samples collected of 3 drums of material and excavation at completion.
- Excavator bucket successfully decontaminated and released.
- Equipment and material surveyed and released.
- Drums closed, labeled, and shipped by DOT hazmat carrier to Port Allen.
- Demobilization

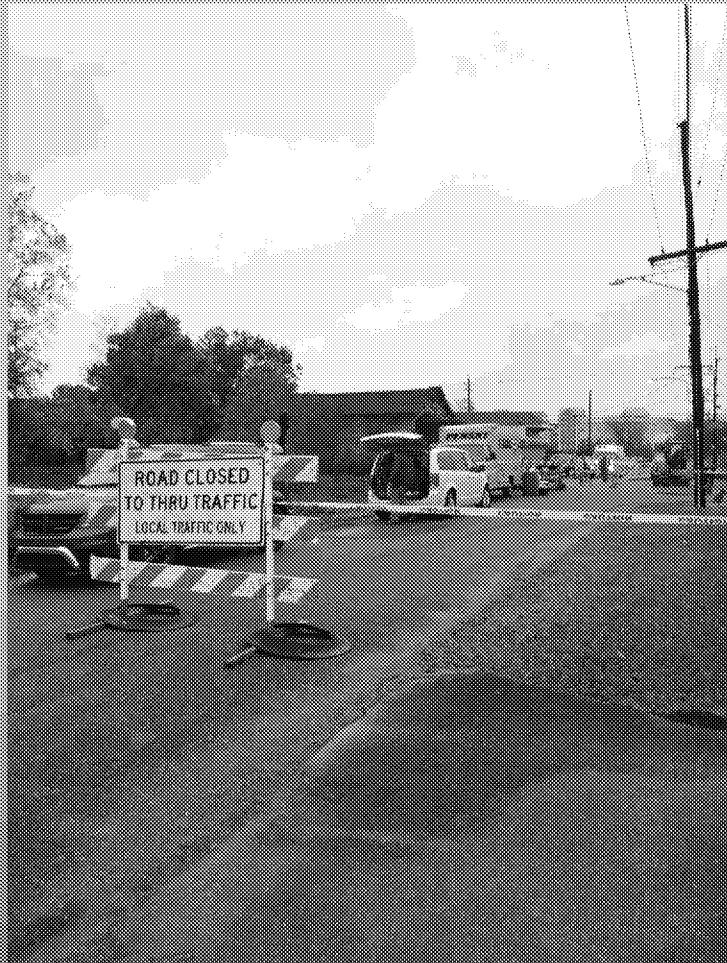
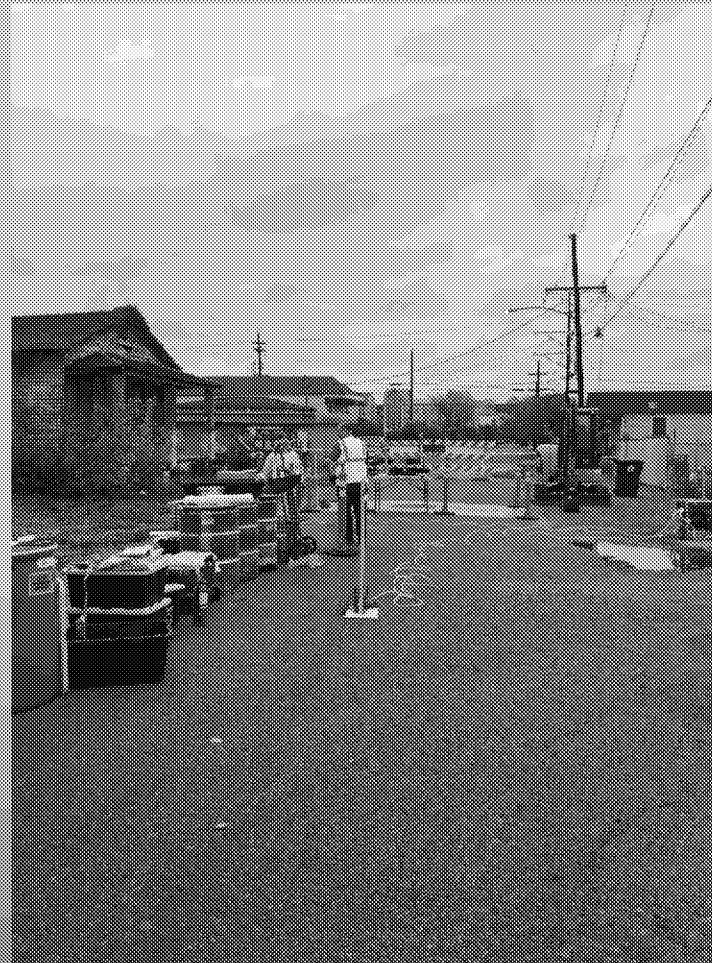
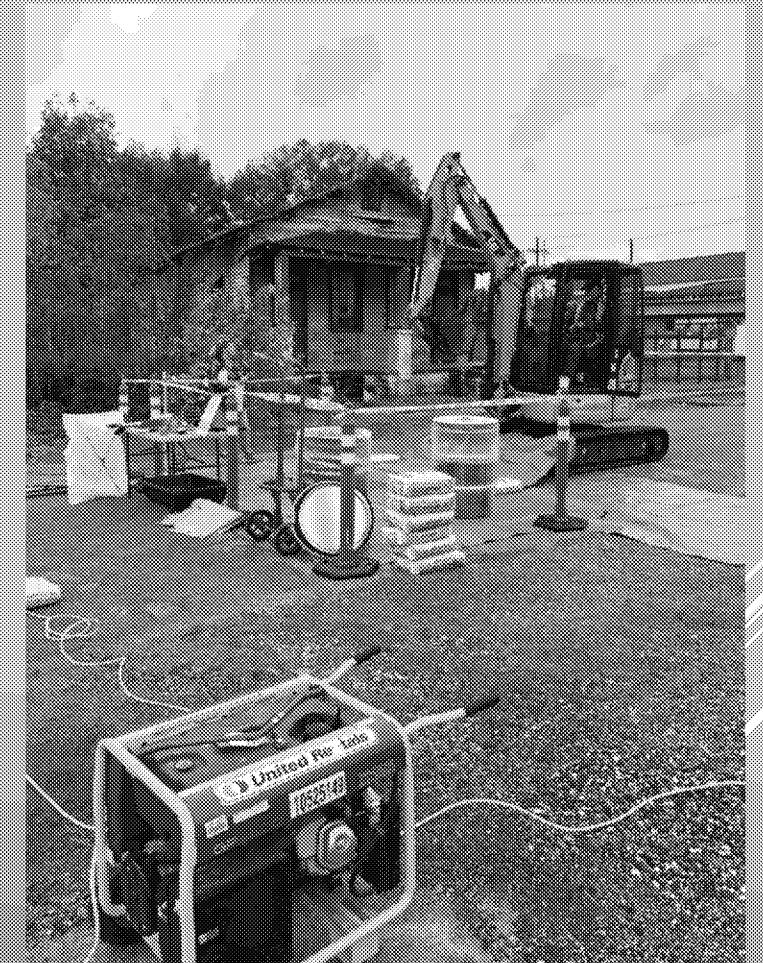
## DESCRIPTION OF PHASE 1 ACTIVITIES

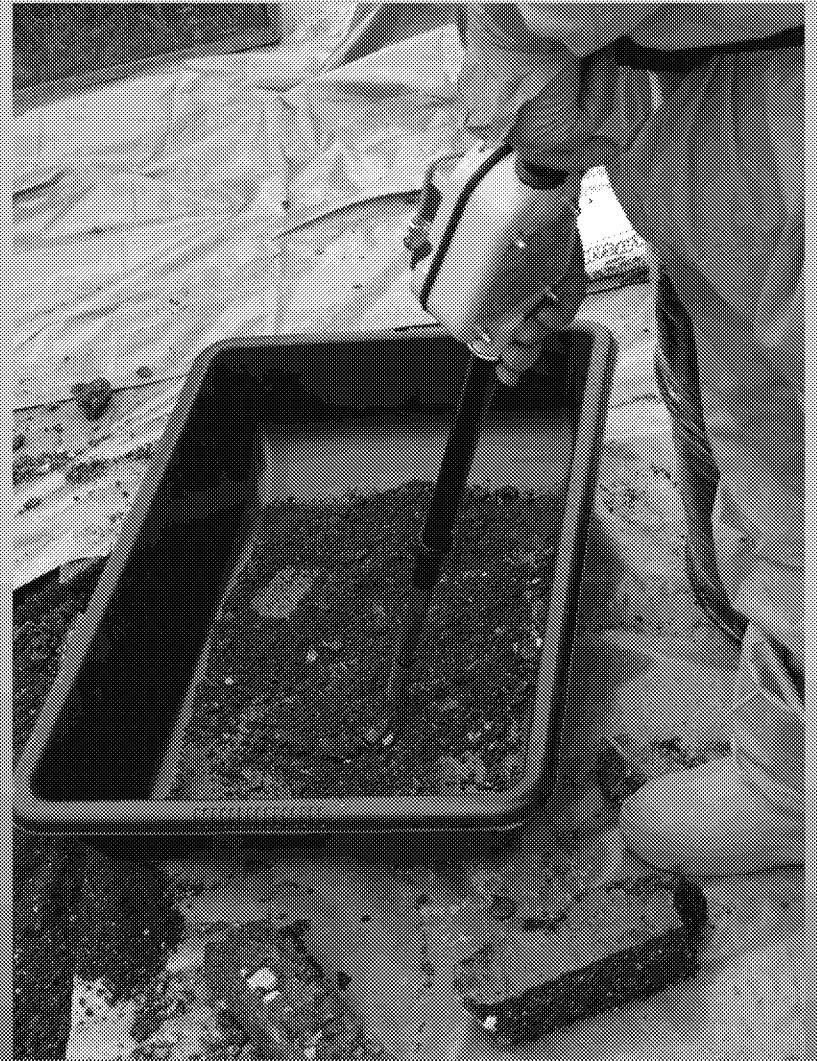
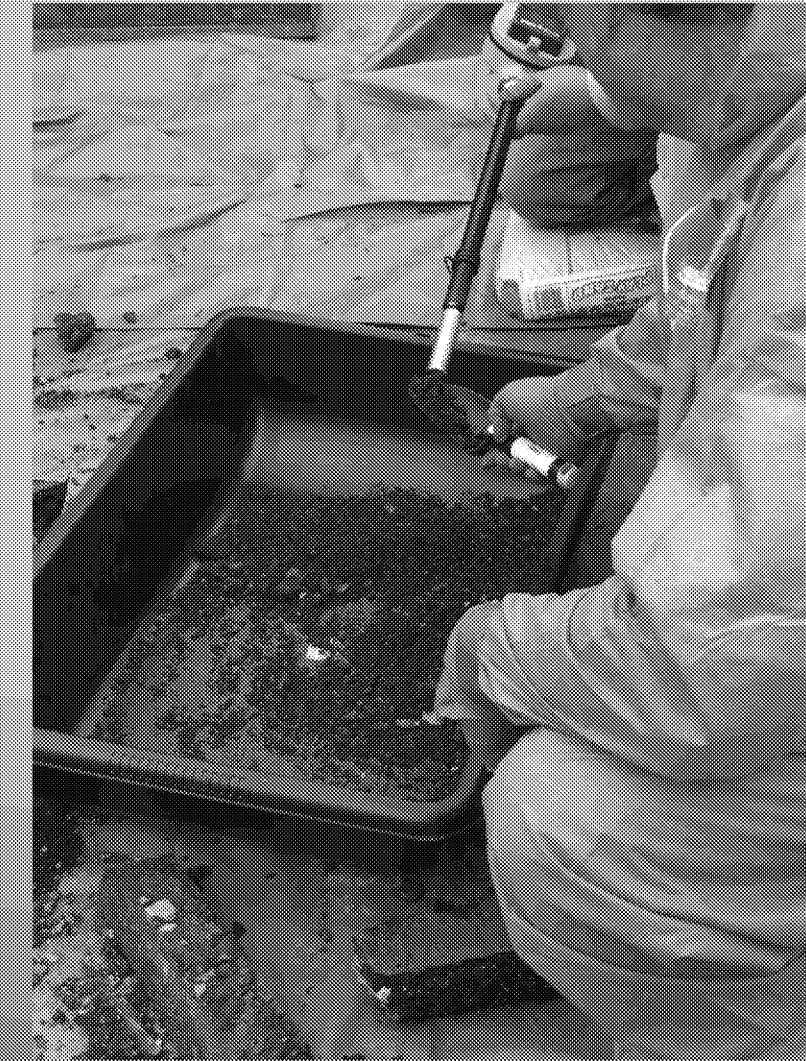
## DISCOVERIES DURING PHASE 1

- ▶ Contamination appears to be below 2<sup>nd</sup> layer of asphalt. It is intermingled with and below a layer of crushed oyster shell roadbase.
- ▶ No “source” or obvious source capsule was discovered during excavation.
- ▶ Localized rate incrementally increased from 1.5 mR/hr to 10,000 mR/hr during excavation.
- ▶ General Area dose rates exceeded posting requirements and required the radiological area to be broadened.
- ▶ Significantly elevated alpha contamination levels were discovered in the excavation.
- ▶ Removable contamination in excess of release limits was detected on the bucket and surrounding plastic.
- ▶ Contamination appears bound to the soil. Decontamination was achieved after removal of soil from equipment and excavator.

- ▶ 10,000 mR/hr “source material” identified, bagged, contained, wrapped in 2 layers of lead blankets, and placed into the center of a sand filled 55-gallon drum for transport to Port Allen.
- ▶ Contact dose rate 53 mR/hr.
- ▶ Other contaminated soil drums range from background to 38 mR/hr.
- ▶ Significant contamination remained after excavating 24-30” ( $>2.5\text{MCPM}$ , 5 mR/hr).
- ▶ There was an unknown metallic cable/debris discovered in the bottom of the excavation.
- ▶ Several other areas of elevated dose rate were discovered around the original location.
- ▶ After consultation with NOLA and LDEQ, the excavation placed in a safe configuration (decontaminated, equipment released, waste removed, backfilled, and cold patch applied).

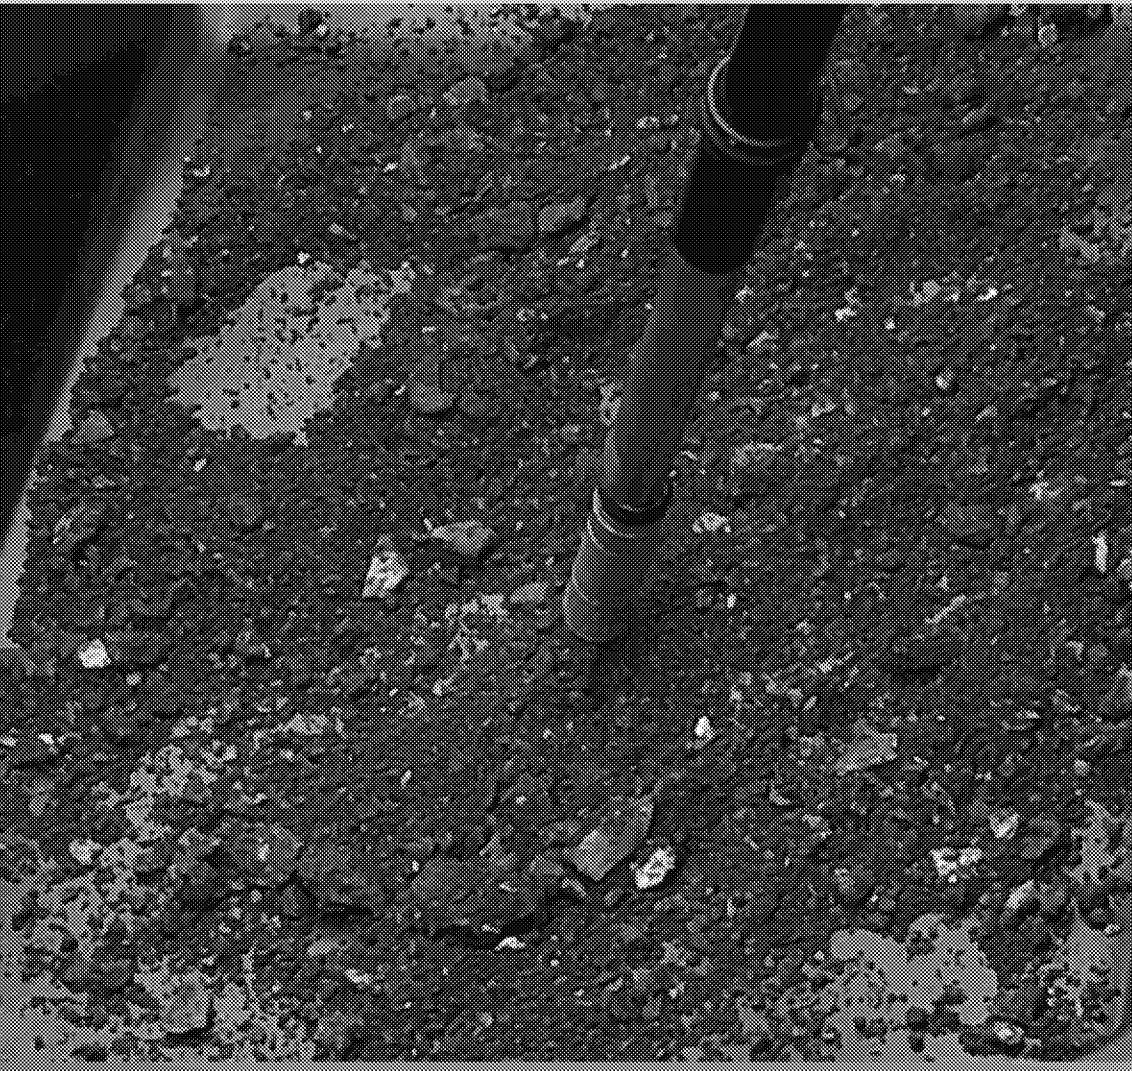
DISCOVERIES DURING PHASE 1

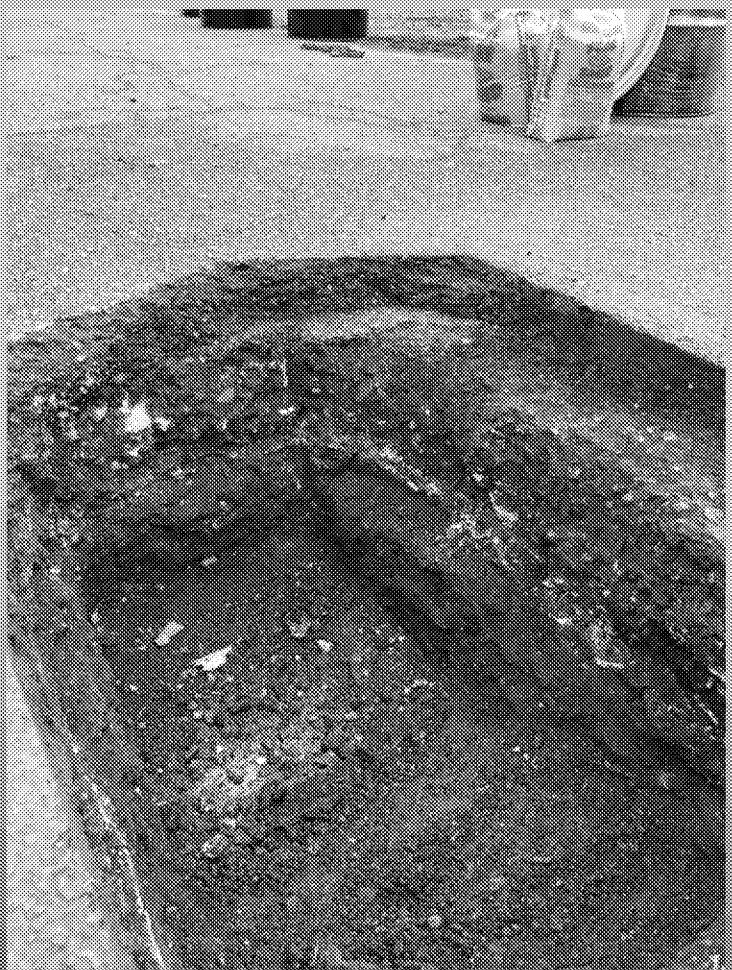
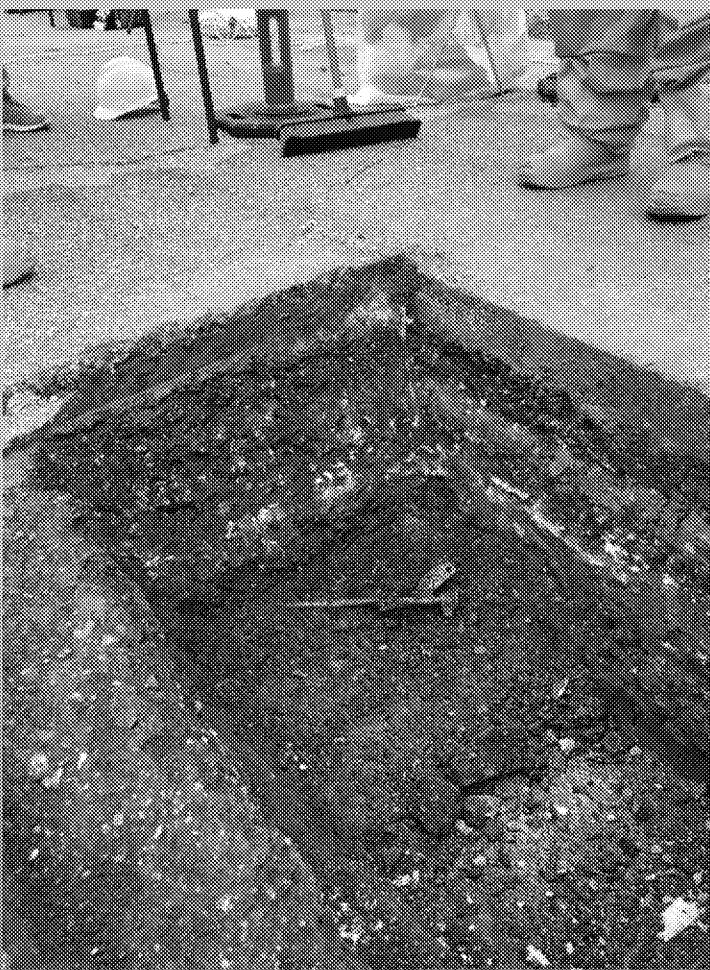
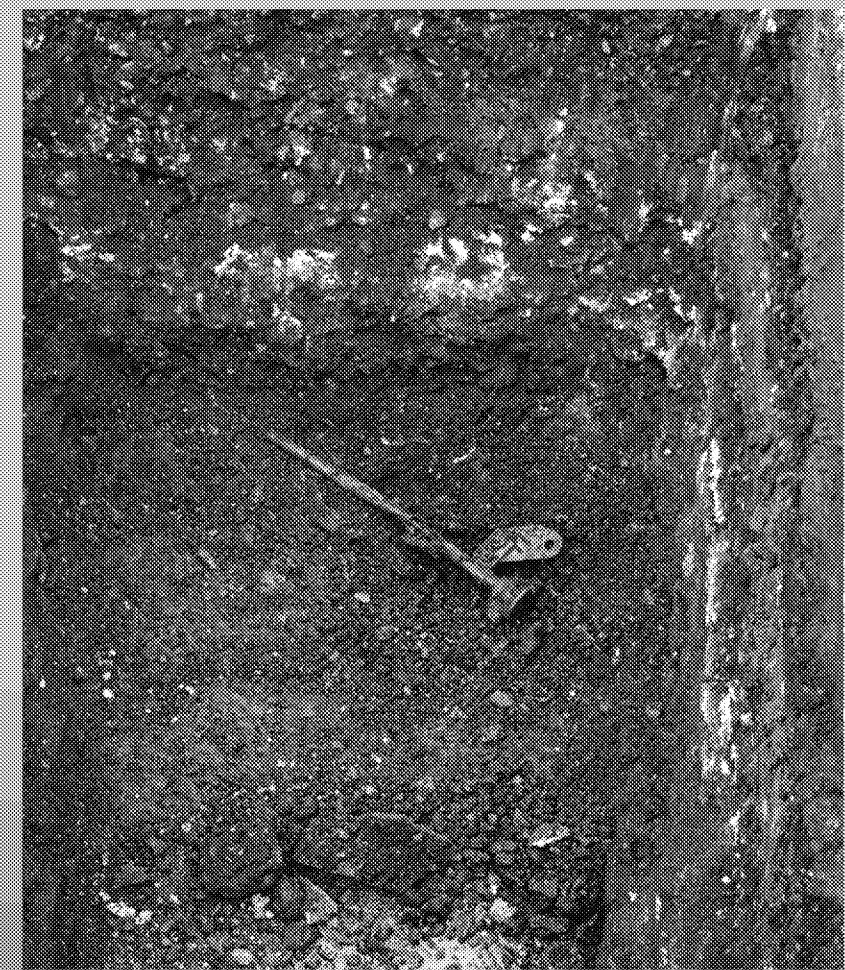
DISCOVERIES DURING PHASE 1

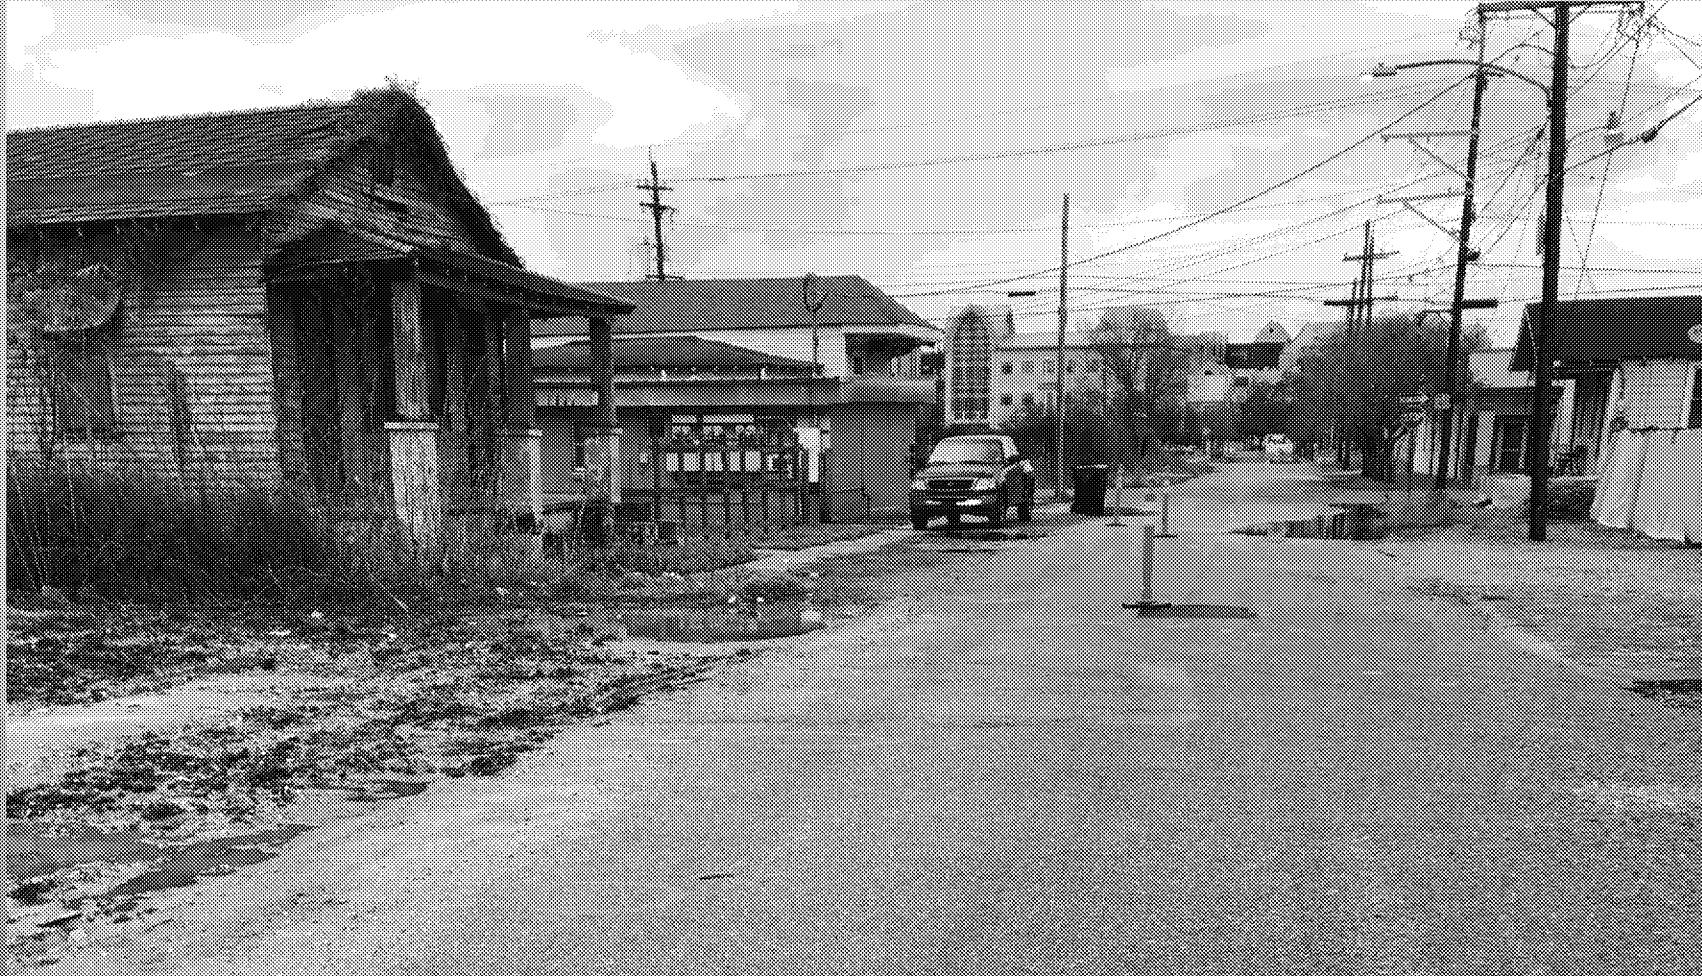
## RESULTS OF GAMMA WALKOVER SURVEY

- ▶ Gamma Walkover Survey was performed on December 3, 2018.
- ▶ Lowerline Street from Edinburgh to Olive and portions of Coolidge was surveyed.
- ▶ Survey parameters and methodology:
  - ▶ 2x2 inch sodium iodide with lead collimator/shield – very sensitive to gamma adiation emitted by Ra-226.
  - ▶ Positioned 4 inches off the ground.
  - ▶ Transitioned linearly at 1-1.5 feet per second.
  - ▶ Radiation levels are recorded each second along with position.
  - ▶ Positional information collected using Trimble GPS.
  - ▶ Accuracy within 24".
- ▶ Survey revealed multiple areas of elevated dose rate along Lowerline Street.

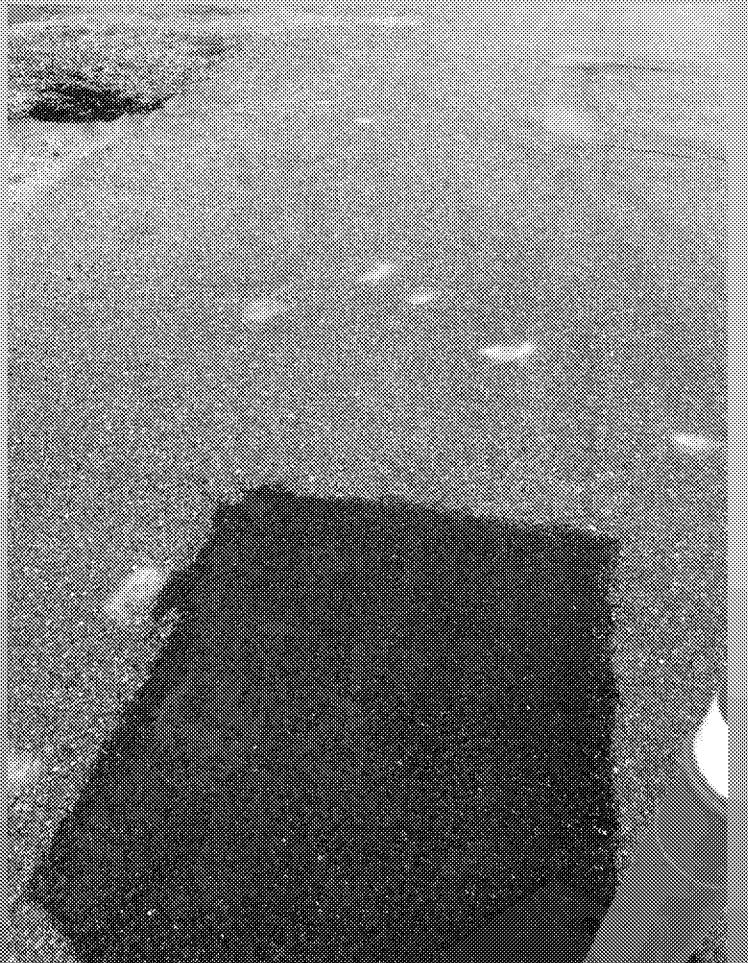
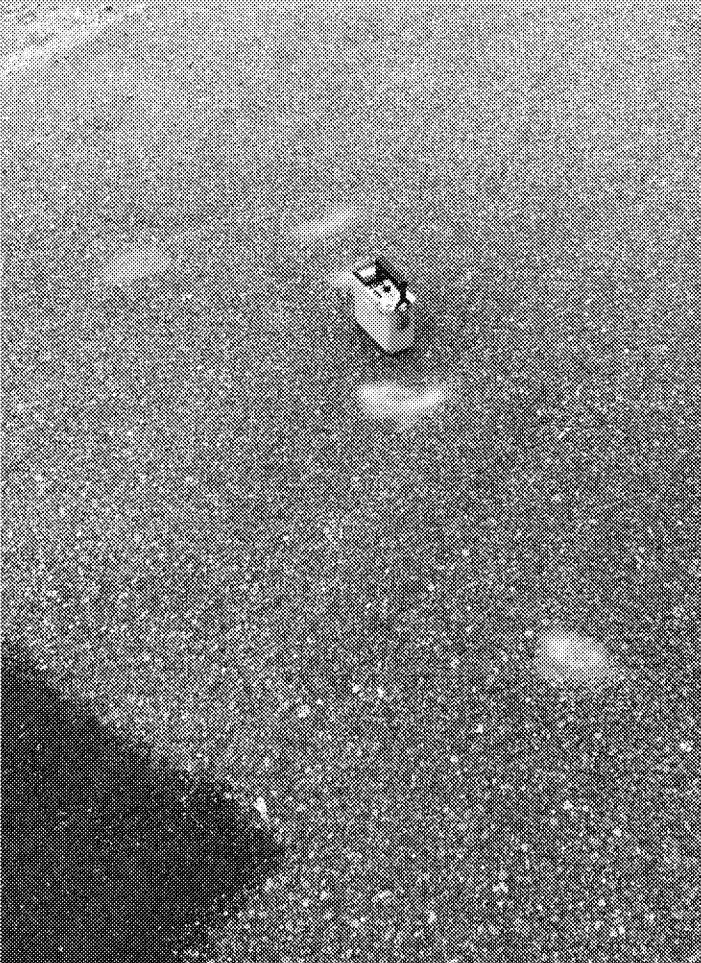
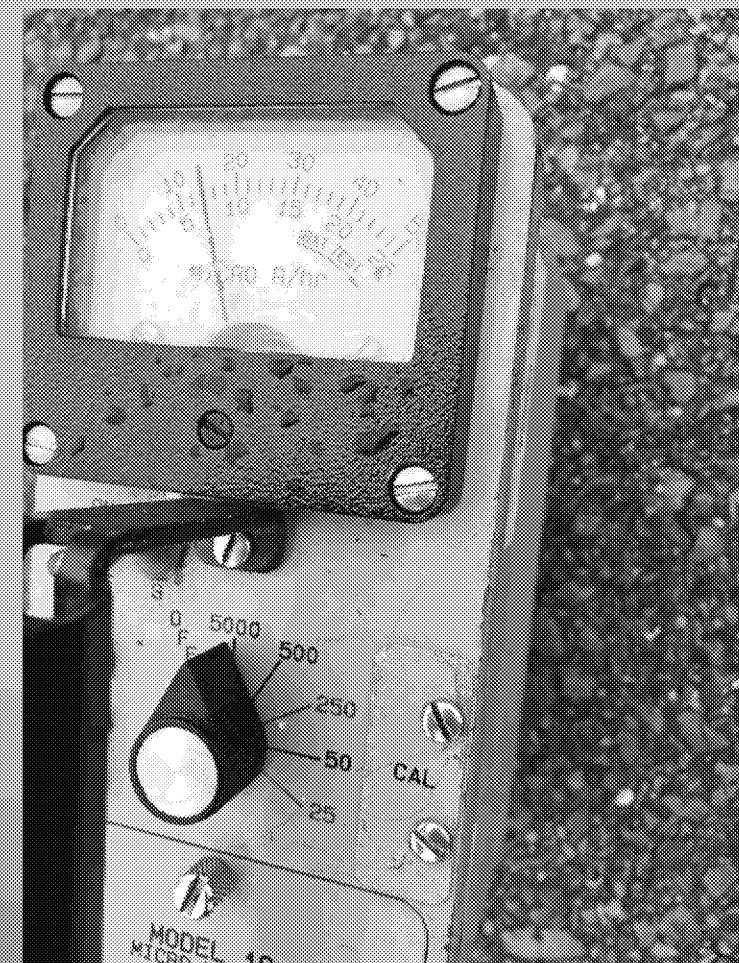
# RESULTS OF GAMMA WALKOVER SURVEY

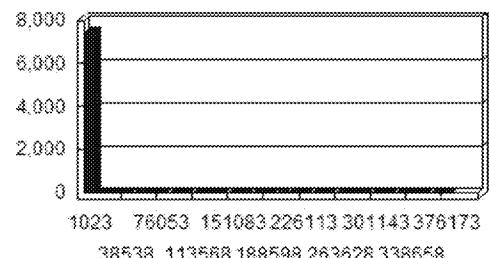
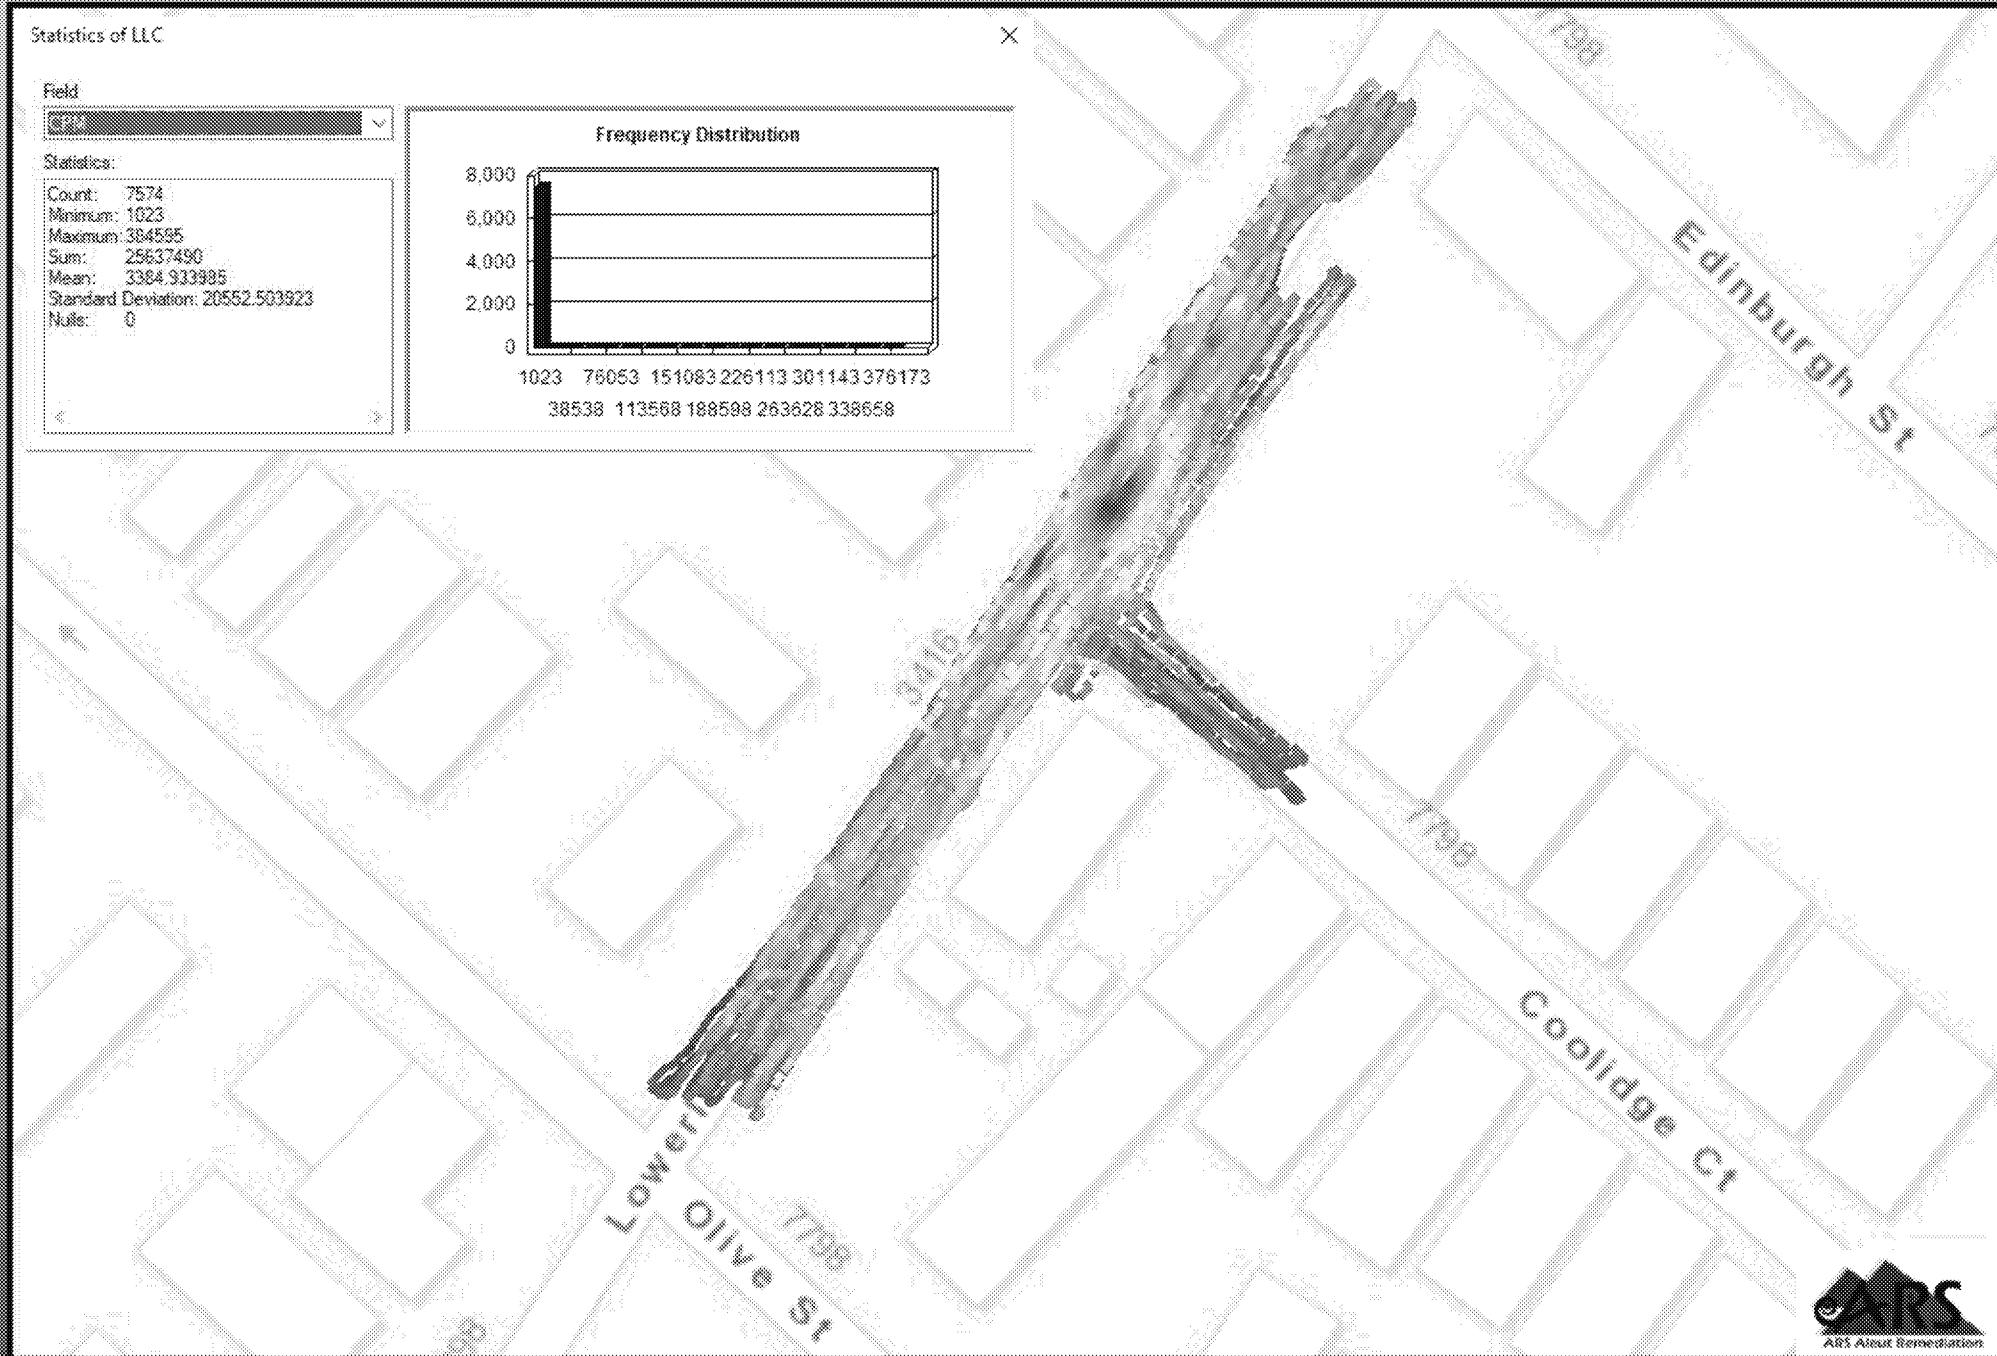
Statistics of LLC

Count: 7574  
Minimum: 1023  
Maximum: 384855  
Sum: 25627450  
Mean: 3384.933985  
Standard Deviation: 20562.503923  
Null: 0

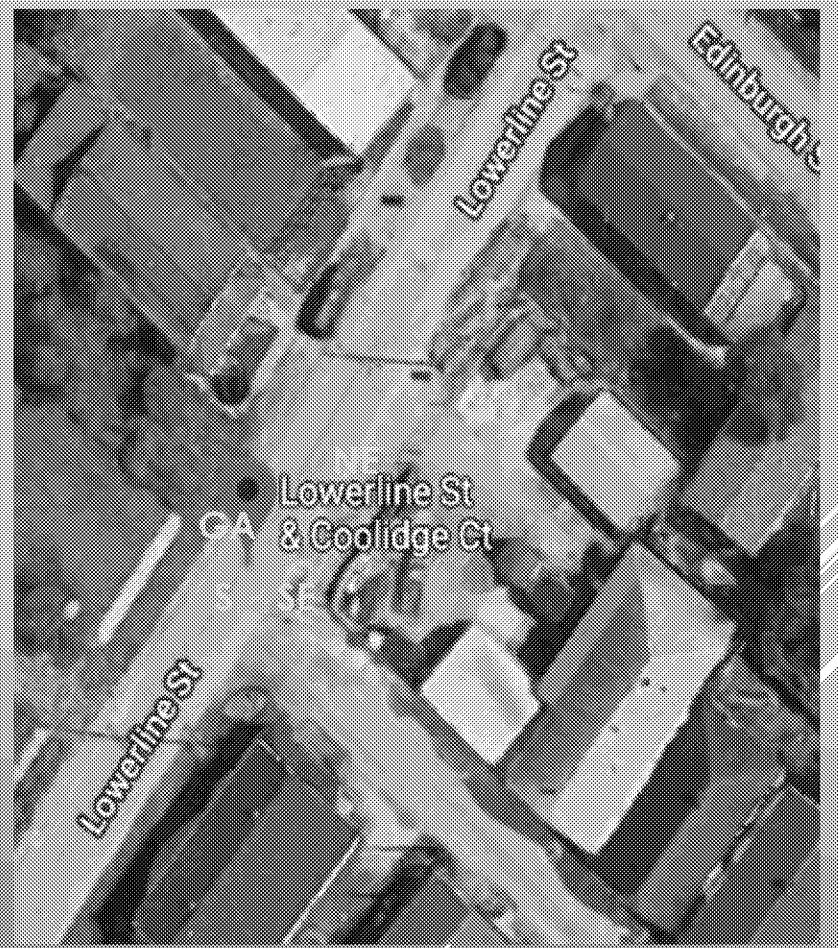
## DOSE ESTIMATE AND AIR SAMPLE RESULTS

<b>Location</b>	<b>Concentration (<math>\mu\text{Ci}/\text{mL}</math>)</b>	<b>Percent Ra-226 DAC</b>	<b>Percent App B Effluent Limit</b>
Breathing Zone	1.93E-13	0.064	NA
General Area	1.44E-13	0.048	16.0
Perimeter NE	2.69E-14	0.009	2.99
Perimeter SE	-4.67E-14	-0.016	-5.19
Perimeter S	1.86E-14	0.006	2.07

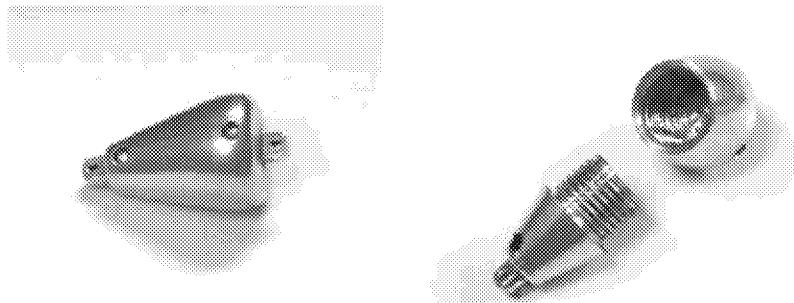
### Radium Industrial Radiography Source (ca. 1940s)

This is an example of an industrial radiography source of the type used in the 1930s and 1940s. Sometimes referred to as a plumbbob, it would have contained approximately 0.1 Ci of Ra-226. Although expensive, radium was used because no other radionuclides were then available of sufficient strength. After World War II, Ir-192 and Co-60 quickly became the radionuclides of choice and the use of radium was abandoned.

The radium (usually radium sulphate) was packed into a cylindrical silver container, which was then placed inside a larger outer capsule. There were two general types of radium capsules: the aluminum type shown at the top of the page, and a steel type. The latter, manipulated at the end of a magnetic handling rod, had two parts: an hexagonal base with a flat bottom (ca. 1" diameter and 1" long) and a short conical cap.

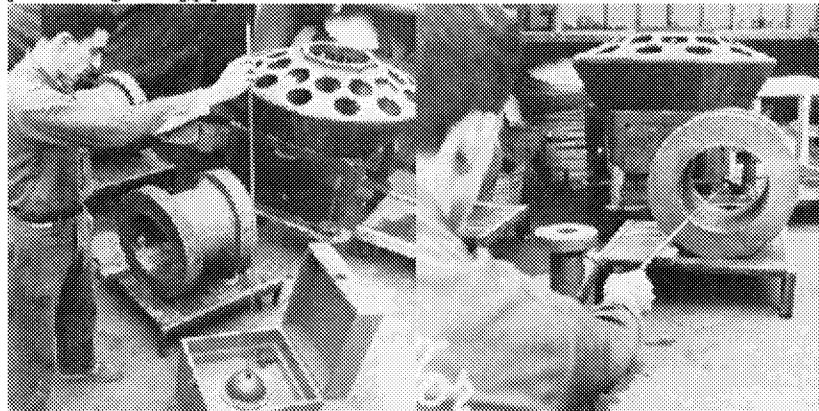
The above B & W photos are from NUREG/BR-0024 *Working Safely in Gamma Radiography*. In the picture on the left, the source is being removed from its shield ("pig"). The photo on the right shows the source being held at the end of a fishpole. The long exposure time and an unsteady hand often resulted in a blurry x-ray image.

When used, the radiography source would be placed on one side of the weld or metal casting being "x-rayed," while a sheet of photographic film was placed on the other side. Exposure times were quite long, e.g., one hour to as much as four days. The source was either handled with a long pole ("fishpole") or tied to a cord. The latter method, for example, would allow it to be pulled through a long pipe.
